# TRANSPORTATION MASTER PLAN

## Existing Conditions Summary Report

Version 1

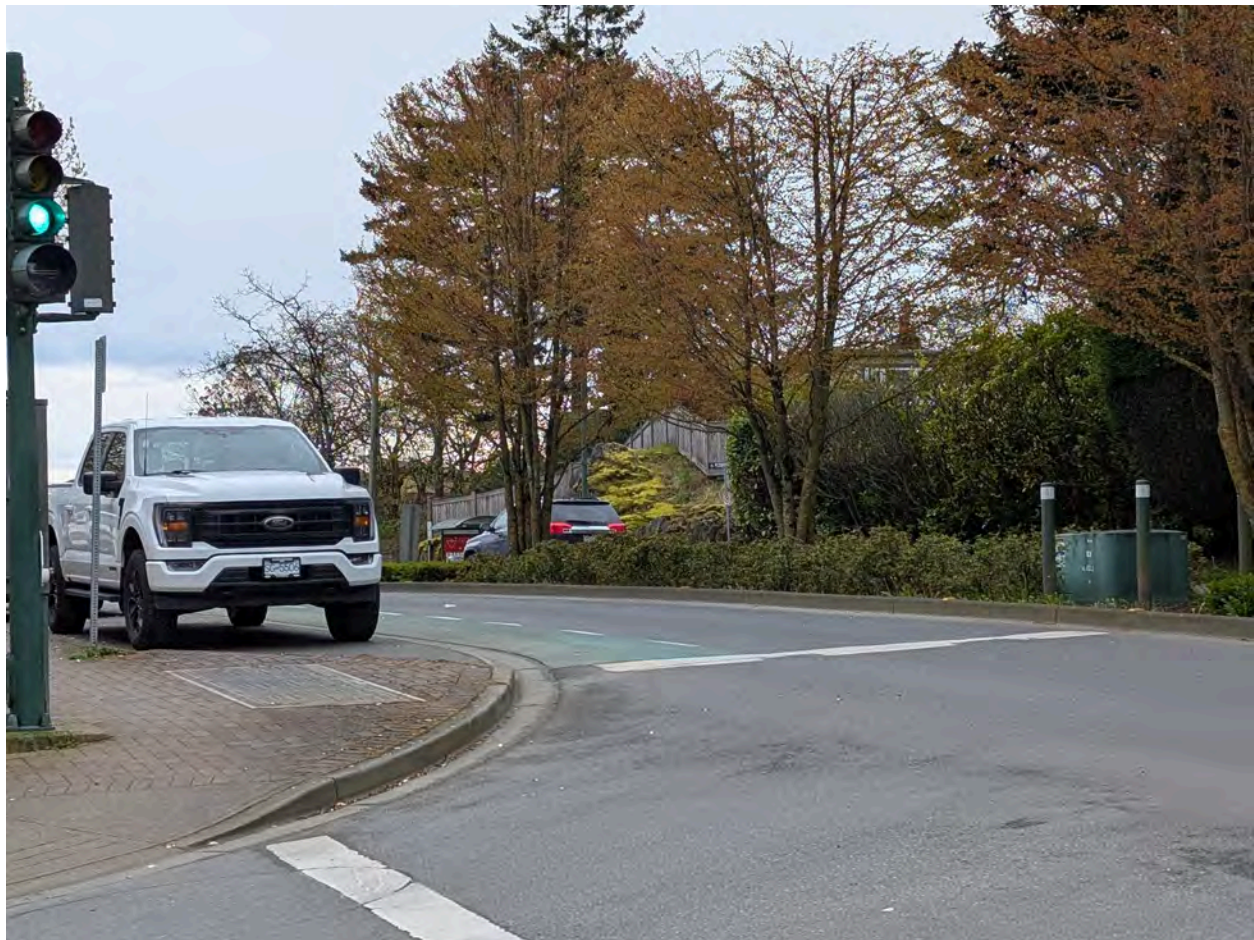
**Figure 4.9: Site Visit Photo – Parked Vehicle Obscuring Sight Line at Island Highway & Stormont Road**

The site visit team observed that the sight line for a vehicle at the southbound approach to Island Highway & Stormont Road can be obscured by a parked vehicle. Specifically, when a vehicle is parked in the on-street space on the near side of Island Highway at Stormont Road (i.e., the white truck in this

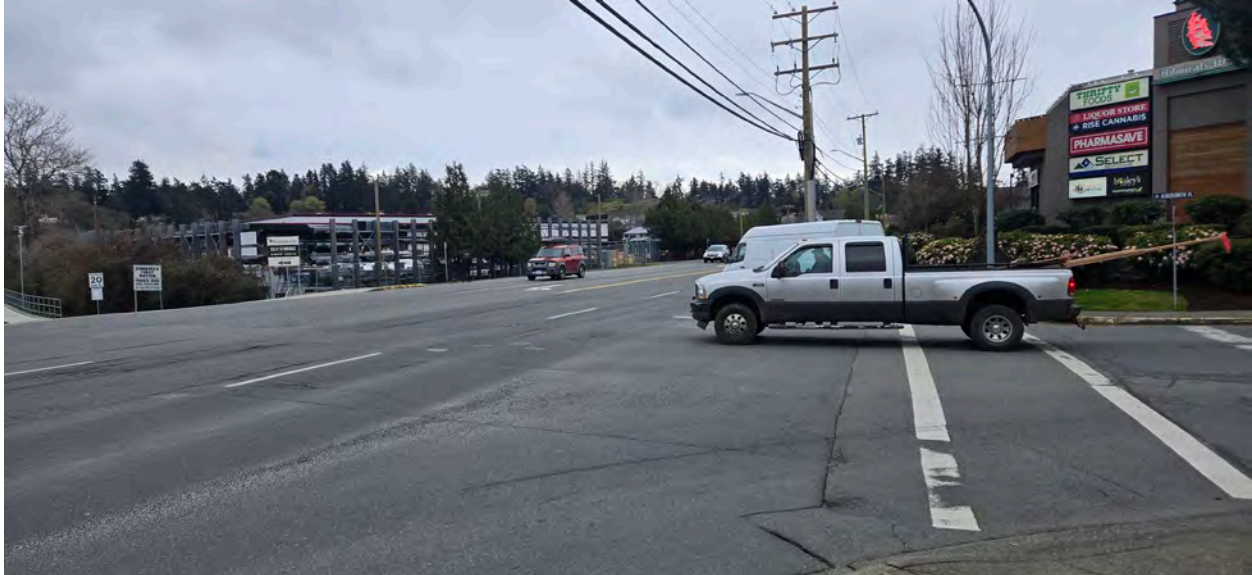
**Figure 4.10: Site Visit Photo – Challenging Left Turn at Admirals Road & Aldersmith Place**

The intersection of Admirals Road & Aldersmith Place/Cooper Road poses hazards for vehicles making left turns from the minor approaches. It is stop-controlled, while Admirals Road has free-flow traffic. This stretch of Admirals Road experiences high traffic volumes and speeds, featuring a four-lane cross-section. In the photo, the silver truck driver has edged past the stop bar and crosswalk markings to improve their sightlines in both directions. Despite this, the site visit team saw the driver wait a considerable time before turning and then accept a risky gap to enter the intersection.

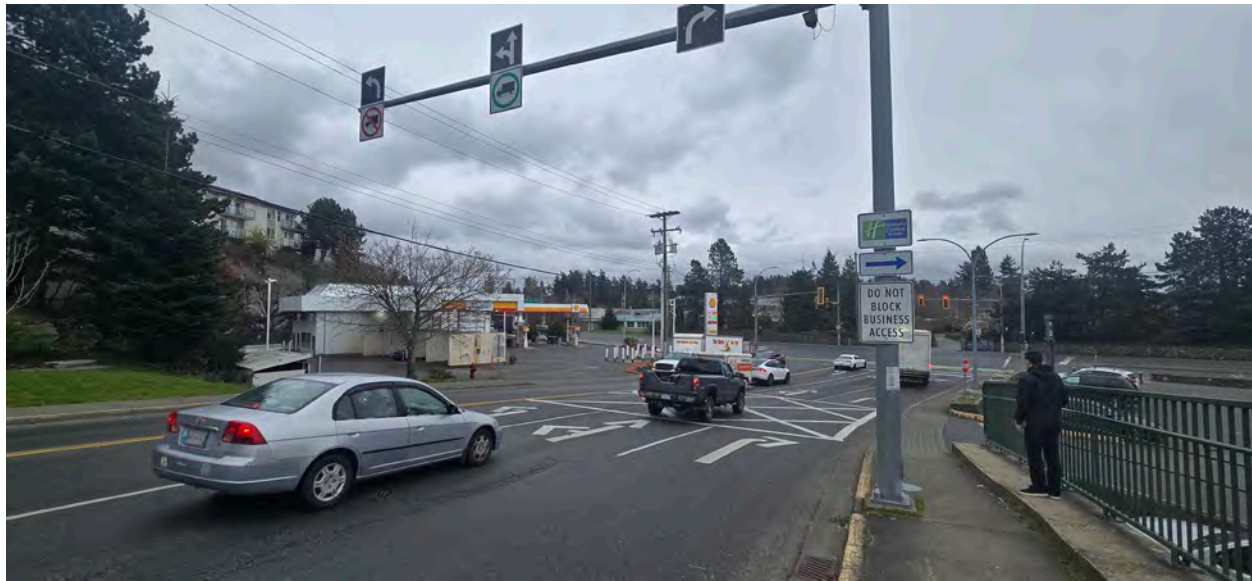
**Figure 4.11: Site Visit Photo – ‘Do Not Block’ Paint Markings on Six Mile Road**

The ‘do not block business access’ sign and the accompanying paint markings are considered a safety issue on a roadway as highly trafficked as Six Mile Road. The paint markings are also within the functional area of the intersection, meaning queues frequently extend past the ‘do not block’ zone.

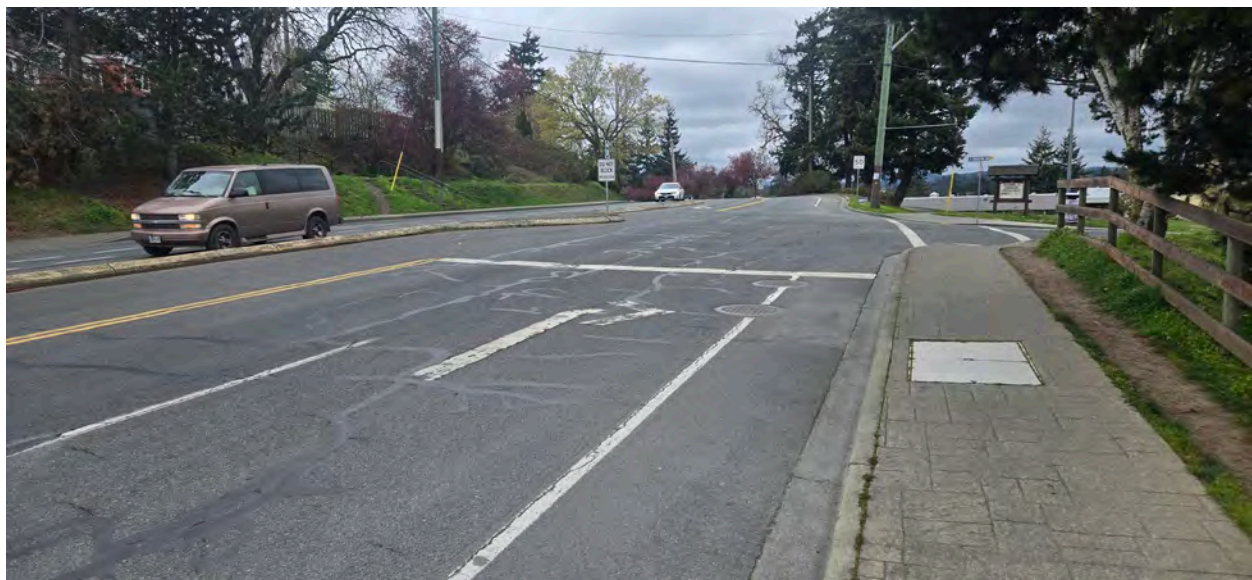
**Figure 4.12: Site Visit Photo – Faded Turn Arrow Paint Marking at Island Highway & Shoreline Road**

The site visit team noted that the paint markings for the right-turn-only lane at Island Highway & Shoreline Road were faded. Additionally, there is only one right-turn lane marking placed just before the westbound lanes reduce from two to one. As a result, drivers might not recognize they are in a turn lane or that they need to merge into the other lane to proceed on Island Highway until they reach the intersection. This delay can cause last-minute lane changes and rear-end collisions.

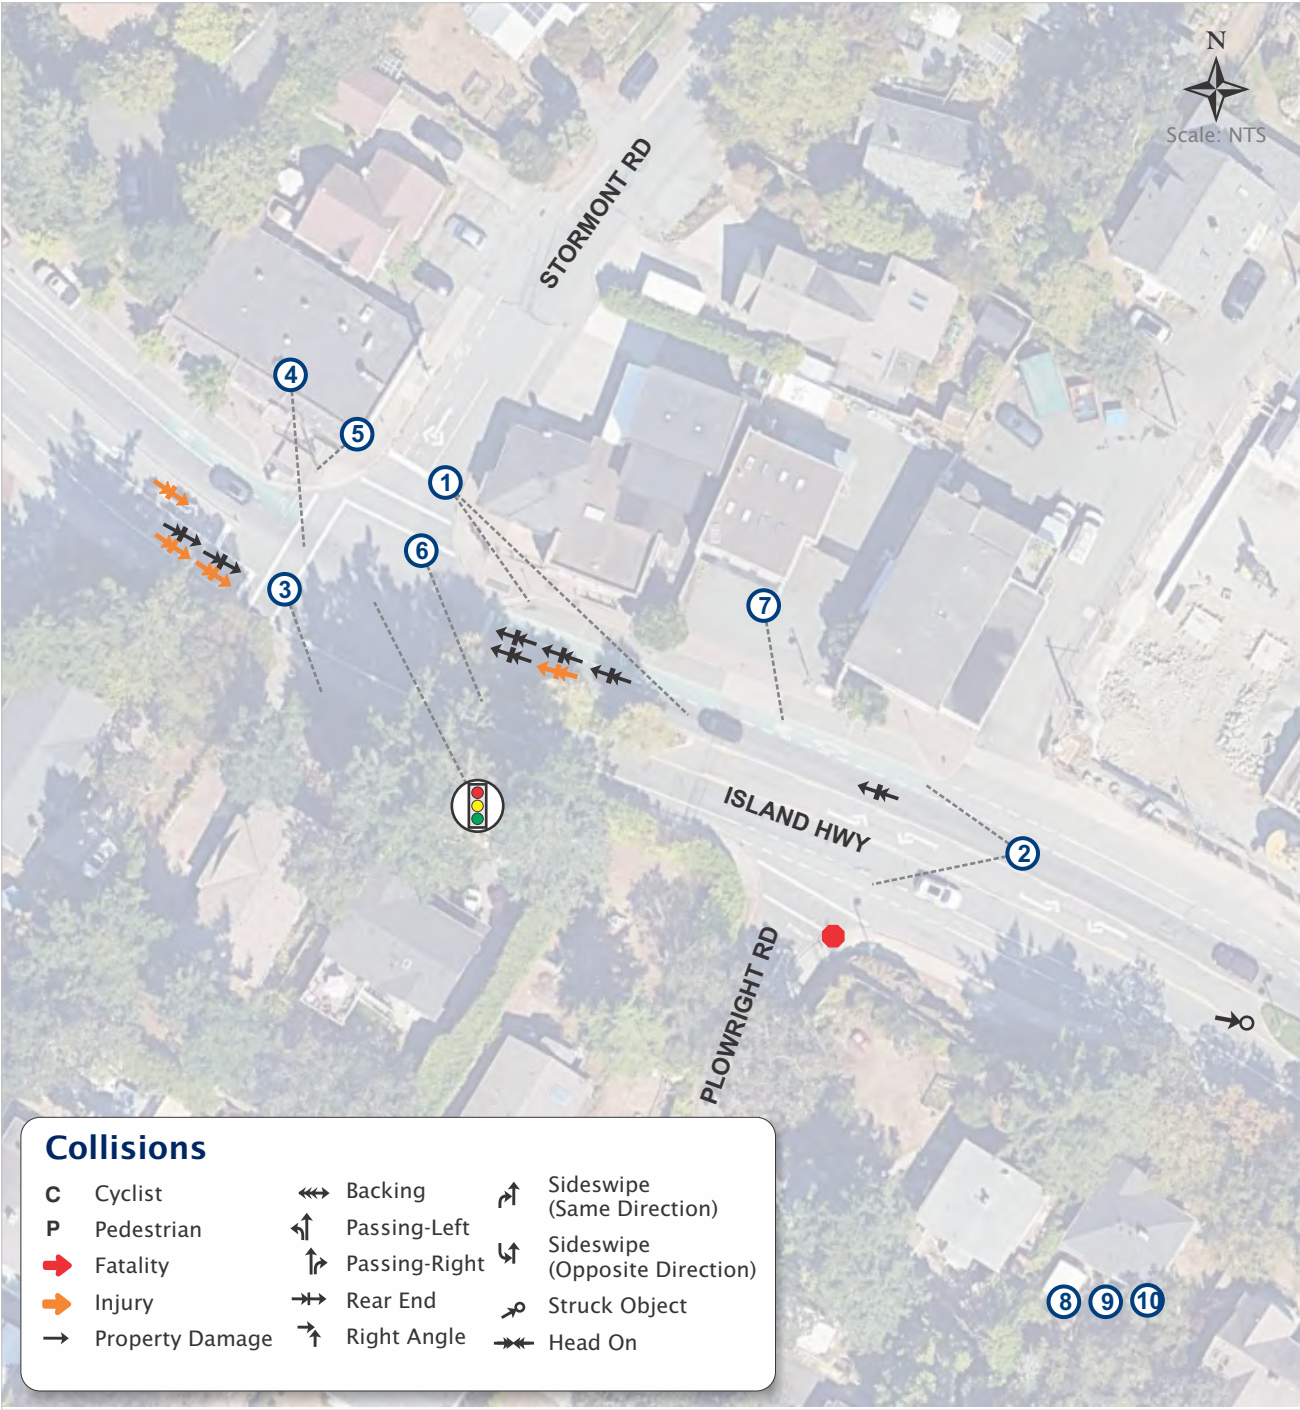
EXHIBIT 4.10: COLLISION ANALYSIS - ISLAND HWY & STORMONT ROAD

Collisions (2019-2024): 18 Incidents (3 / Year)

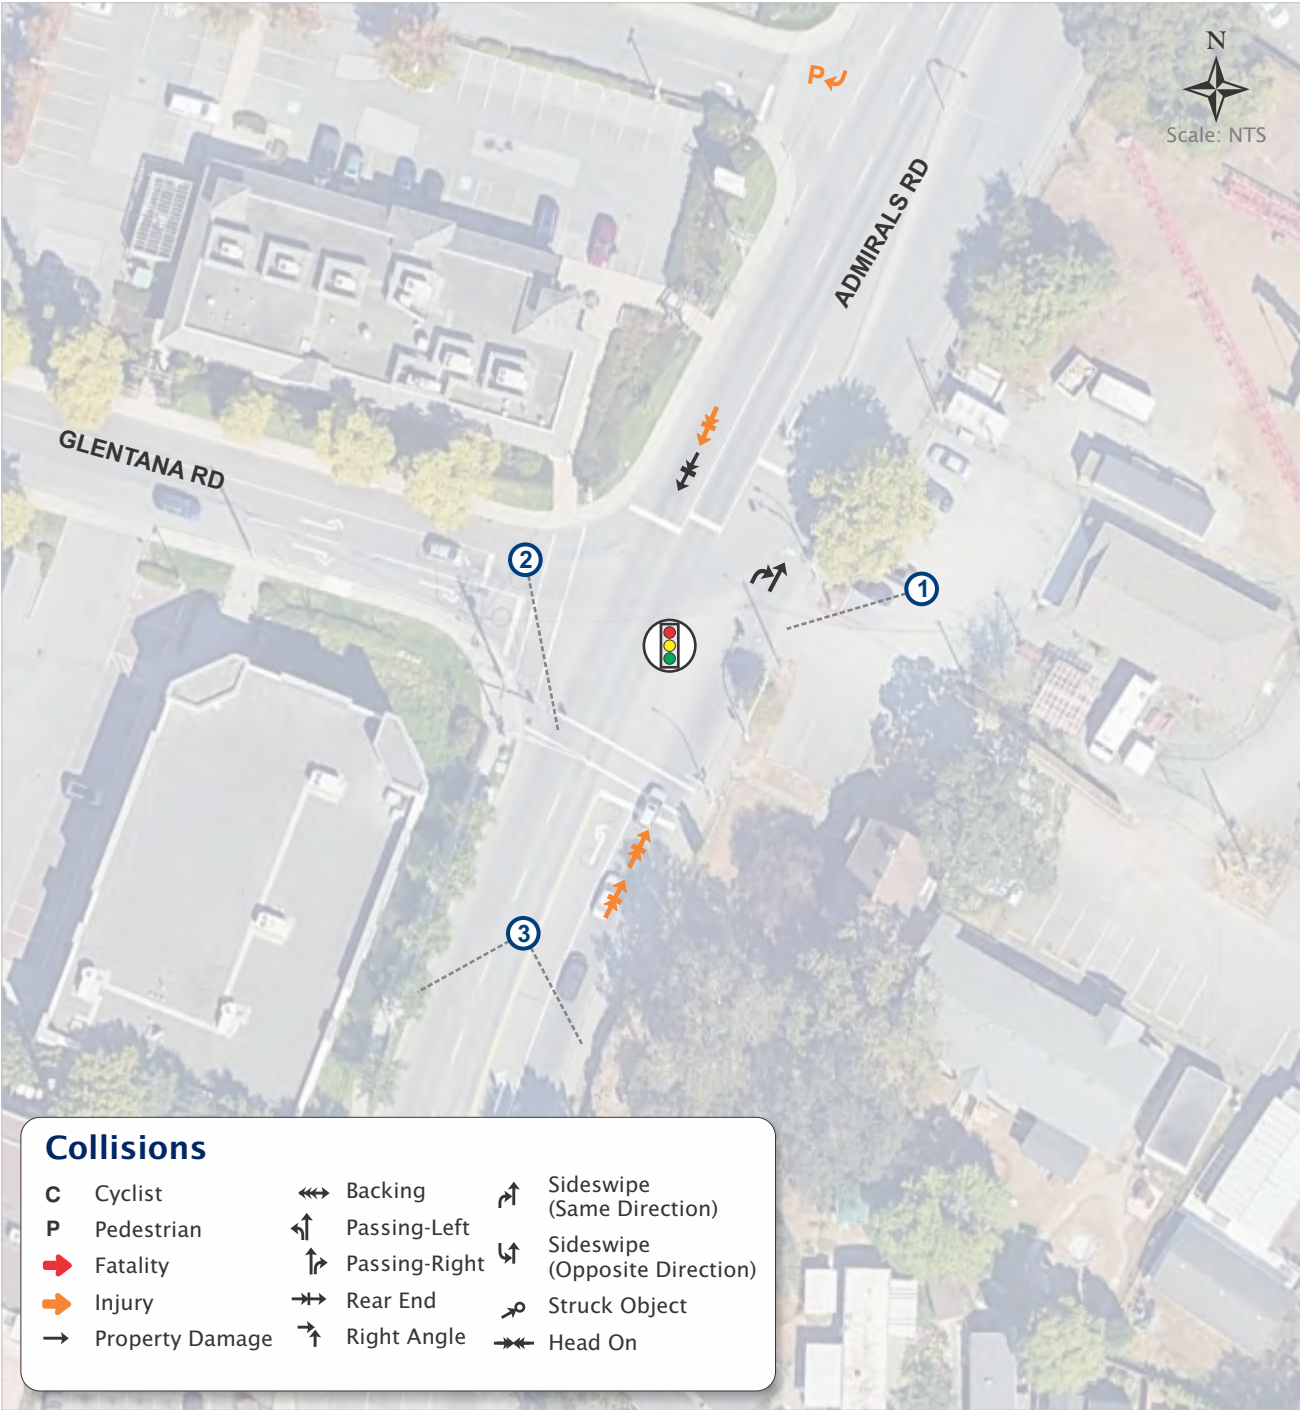
EXHIBIT 4.13: COLLISION ANALYSIS - ADMIRALS RD & GLENTANA AVE

Collisions (2019-2024): 7 Incidents (1 / Year)

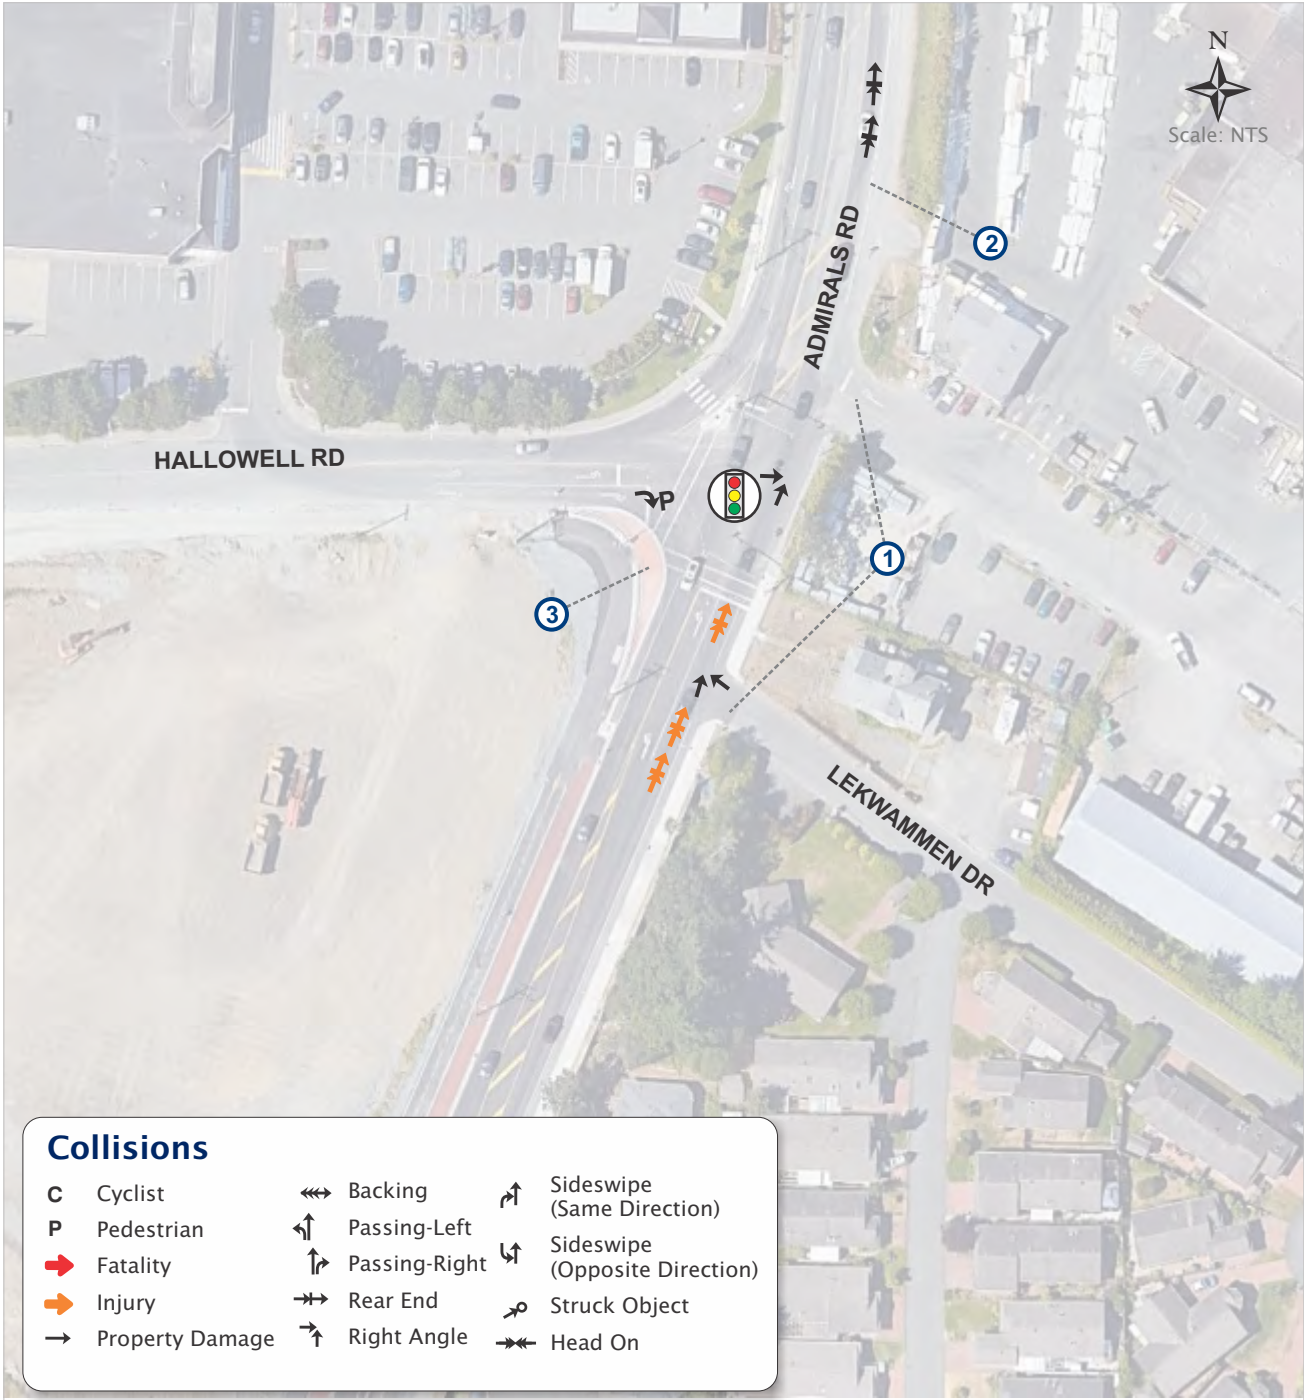
EXHIBIT 4.15: COLLISION ANALYSIS - ADMIRALS RD & HALLOWELL RD

Collisions (2019-2024): 15 Incidents (3 / Year)

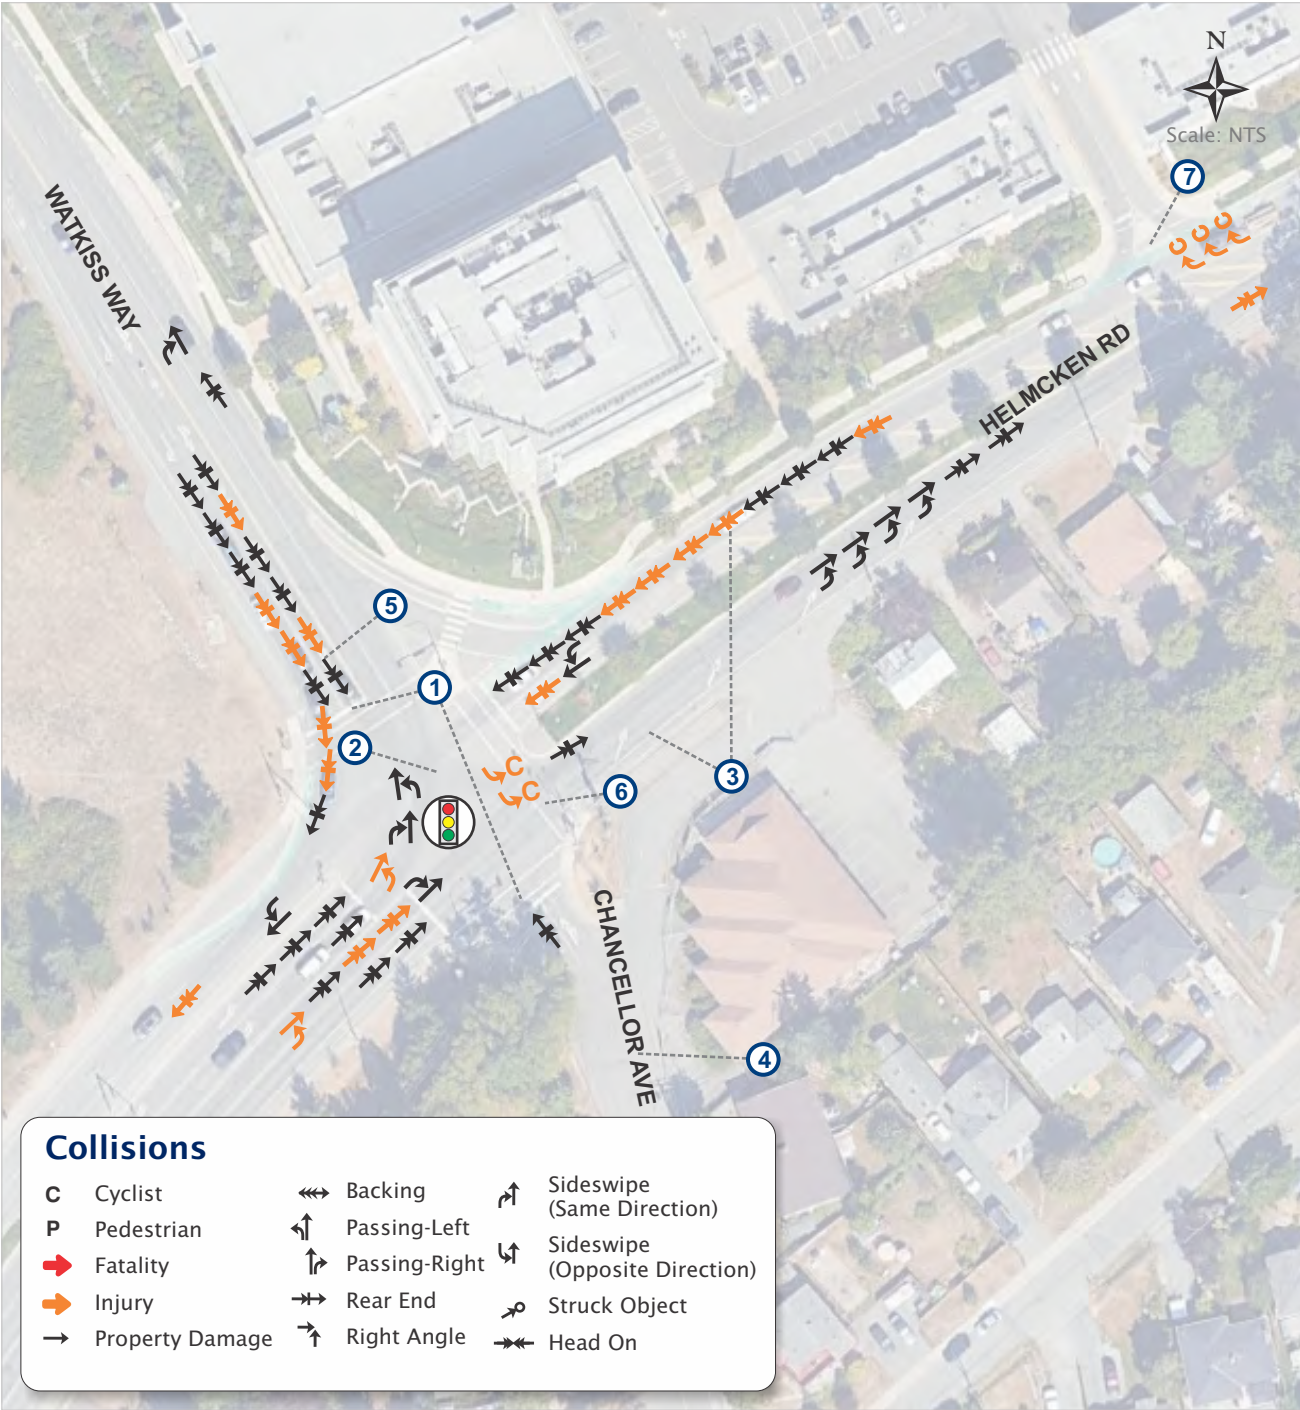
EXHIBIT 4.16: COLLISION ANALYSIS - WATKISS WAY & HELMCKEN RD

Collisions (2019-2024): 87 Incidents (15 / Year)
